### **Timber Strengthening Systems operated on the Vasari's Ceiling in Palazzo Vecchio**

Timber Strengthening Systems operated on the Vasari's Ceiling in Palazzo Vecchio / P.P.Derinaldis; G. Tampone; G. Tempesta. - STAMPA. - (2006), pp. 421-428. (Intervento presentato al convegno Structural Analysis of Historical Construncions. Possibilities of numerical and experimental techniques tenutosi a New Delhi).

## Timber Strengthening Systems operated on the Vasari's Ceiling in Palazzo Vecchio

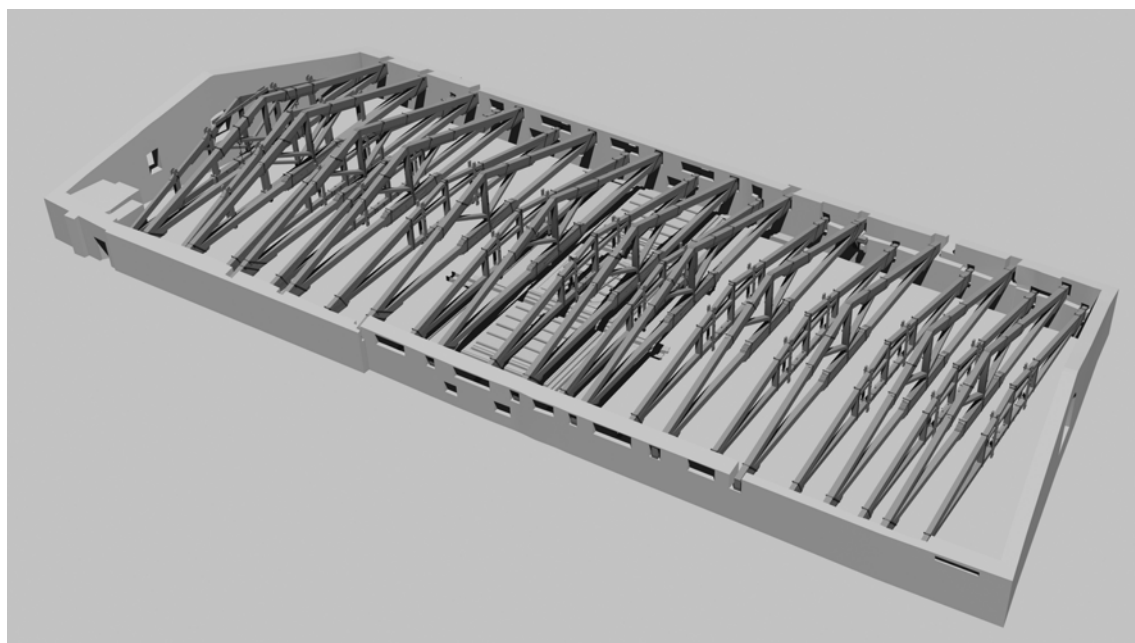
Figure 1: “Salone dei 500”. Perspective view of the garret.

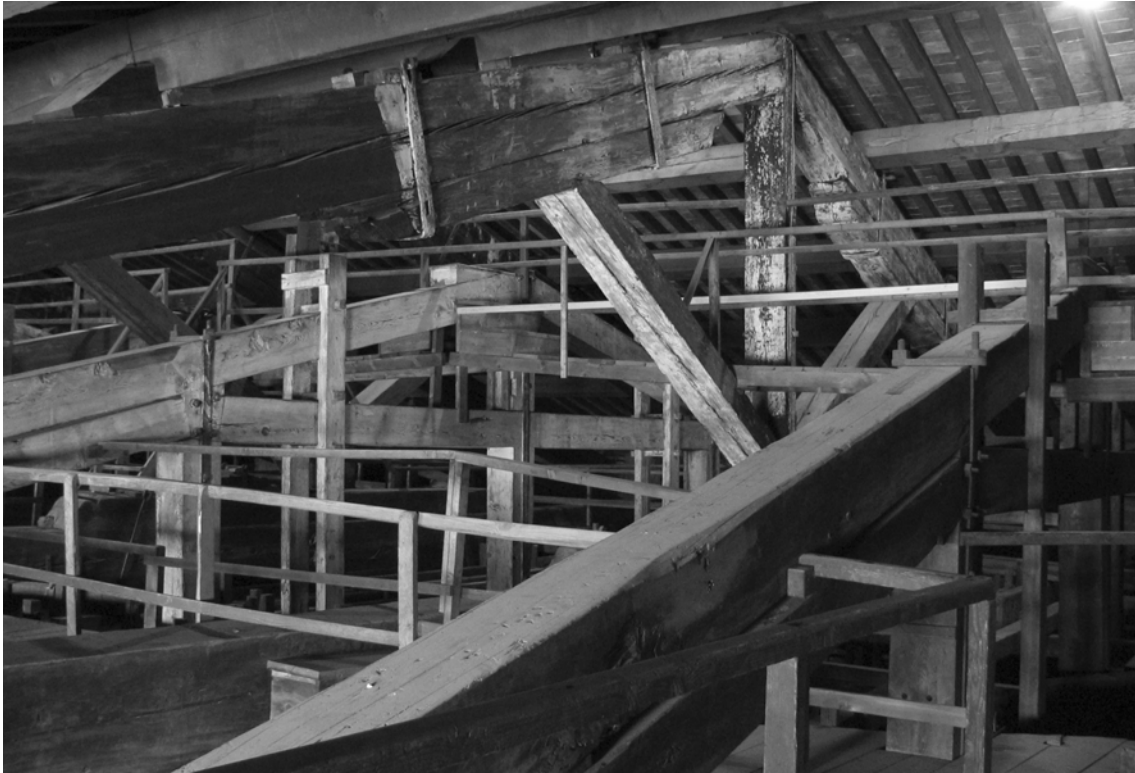
Figure 2: Panoramic view of the “Salone dei 500” garret, in the middle the vasarian trusses.

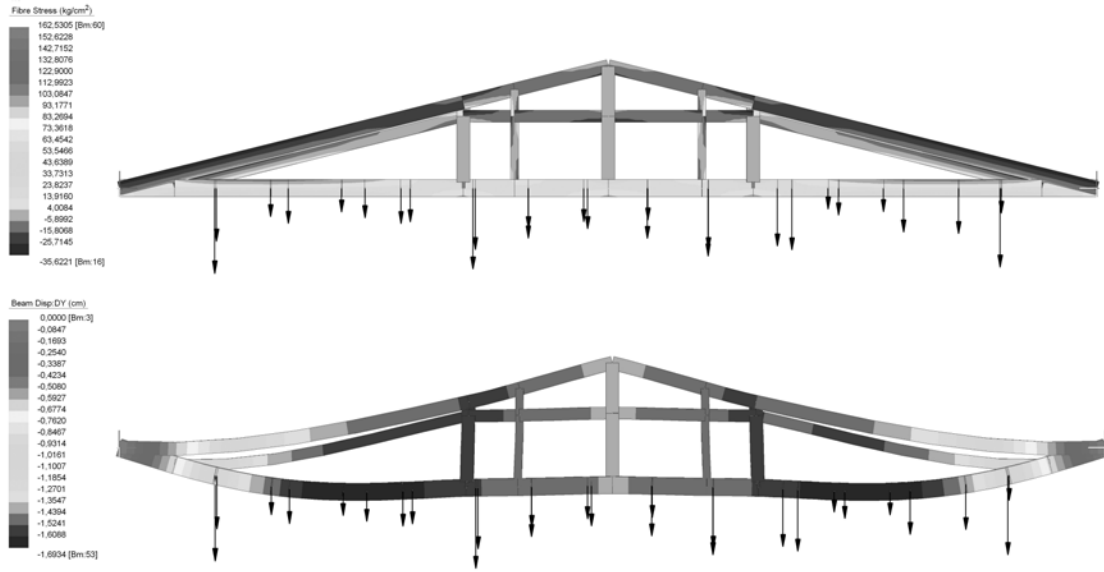
Figure 3: Numerical model of the 7<sup>th</sup> Graldi's truss. The painted ceiling is suspended from this truss. Structural unit subjected to static loads. Stresses (up). Vertical displacements (down).

The structural analysis for the Giraldi's trusses shows that the stresses in the wood vary in a very narrow range and the values are small (see Table 4). A deformation curve of the rafter different from that of the under rafter and a tendency of these members to share have been observed.

With internal fixed joints		With internal joints like hinges	
Stress	Displacement max (y)	Stress	Displacement max (y)
N/cm <sup>2</sup>	cm	N/cm <sup>2</sup>	cm
1593.88 (metallic elements)	-1.7	1650.18 (metallic elements)	-2.5
-349.33		-480.45

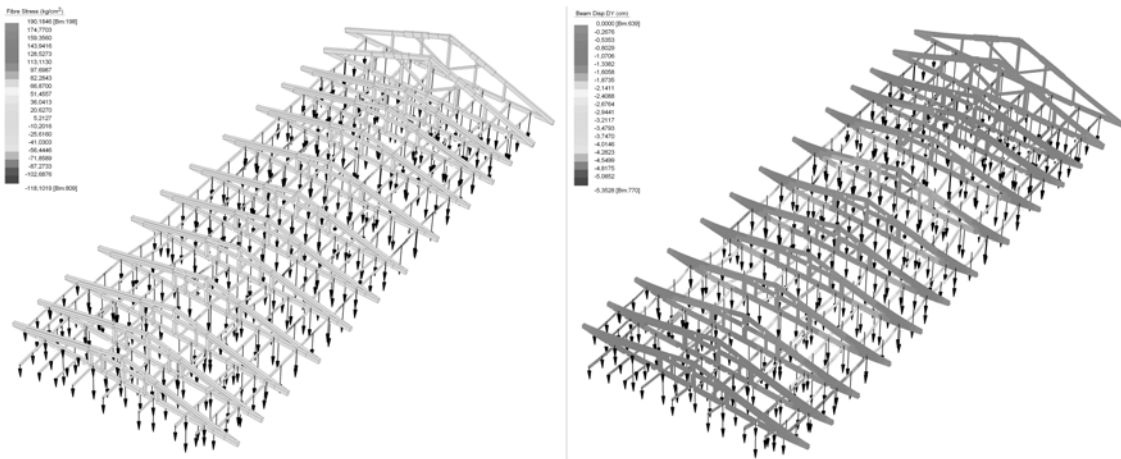
Figure 4: Numerical model of the trusses which sustain the false ceiling and of the interposed joists. Structural system subjected to static loads. Stresses (right). Vertical displacements (left).

In the complete structural model, defined by the parallel collection of wooden trusses, a system of the wooden joists has been considered arranged among the singles structural units. Both the self weight load of the ceiling and the loads trasmitted by the metallic and timber suspension devices have been applied directly to the wooden joists.

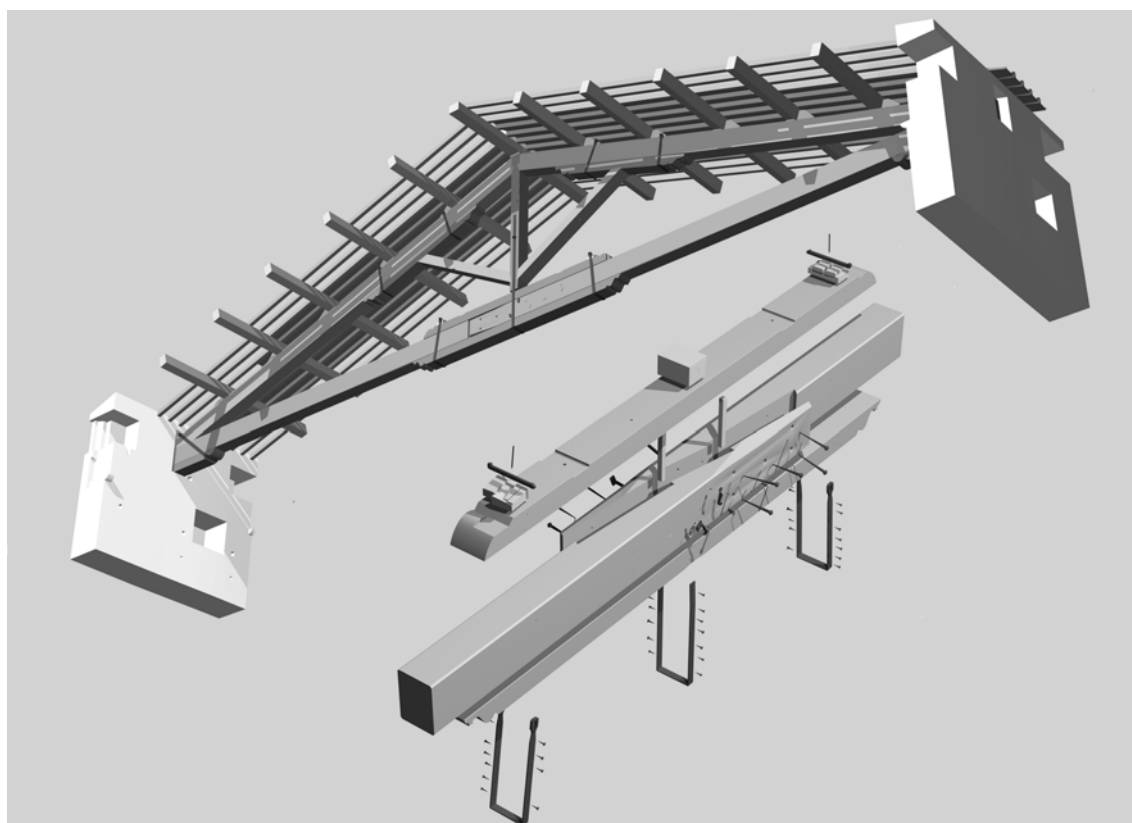
Figure 5: The vasarian truss; exploded view of the chord.

The chords are made, in account of the length, 24 m average, of two elements connected in the middle by a seal joint (a simplified “Jupiter’s arrow joint”) the contact surfaces of which are resting in vertical planes, also inclusive of a superior and a slightly longer inferior element. These, acting as brackets, are intended to stiffen the connection and to make it suitable to resist also to bending moment: this is generated by the not negligible self weight of the chord and by the weight of the false ceiling. The central connection is completed with nails and bolts of various type set untidily (a sign of multiple interventions) which stop any mutual motion and do not allow adjustment; very sophisticated the bolts, which are to be attributed to the Vasari’s time. Besides the four pieces are tightened by two end iron ties. These have no wedges (today) but a single upper horizontal connector and they can be tightened to the woods only inserting wooden thicknesses.
